## TEST REPORT: 4787836172.1

**Product:** Integra click-on hinge  
51BSH5050005000 - ISO 9227 –  
72h (isp. 24h)

EN ISO 9227: 2012 Corrosion tests in artificial atmospheres - Salt spray tests.

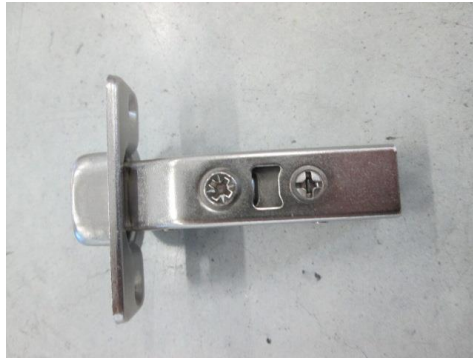
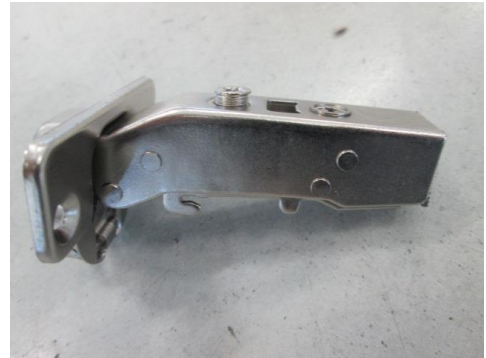
Samples before test :

**Sample defects before the test: NO VISIBLE DEFECTS**

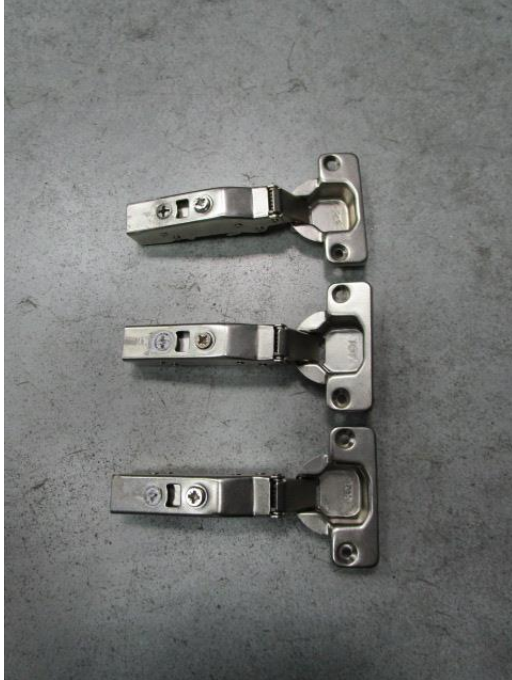
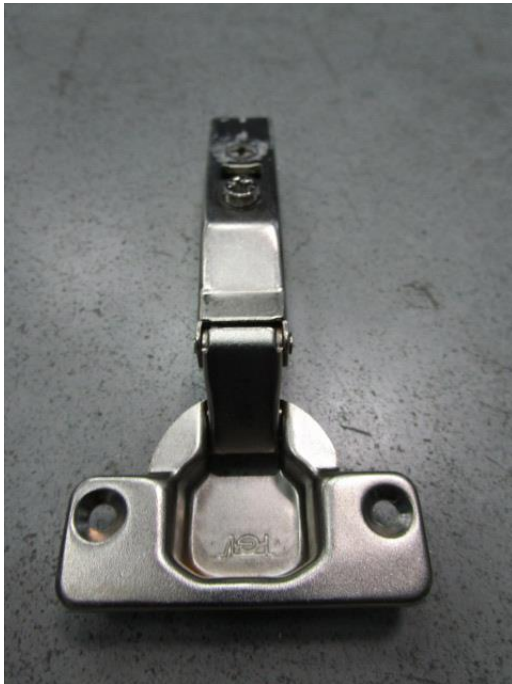
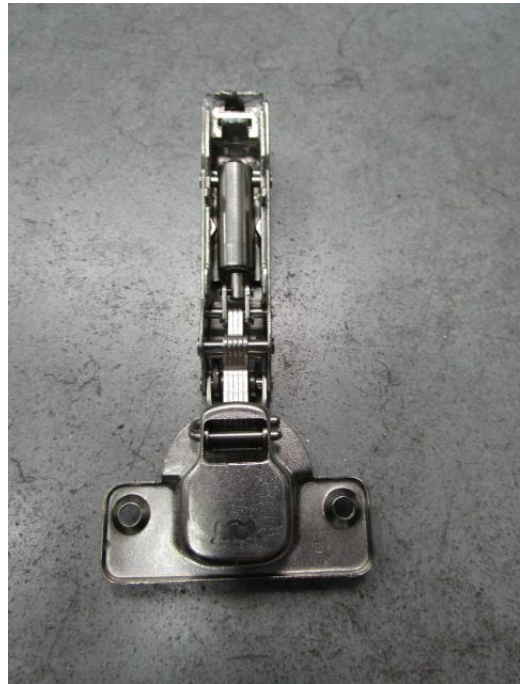
After 72 hours:

Number of controls tested sample	Time of exposure (hours)	Observations
First control	24	No defect
Second control	48	No defect
Third control	72	No defect
